‘I WAS NEVER MORE IN LOVE WITH AN OLDE HOWSE NOR NEVER NEWE WORKE COULDE BE BETTER BESTOWED’: THE EARL OF LEICESTER’S REMODELLING OF KENILWORTH CASTLE FOR QUEEN ELIZABETH I

Richard K Morris, FSA

APPENDIX A: MODIFICATIONS TO THE TILTYARD DAM

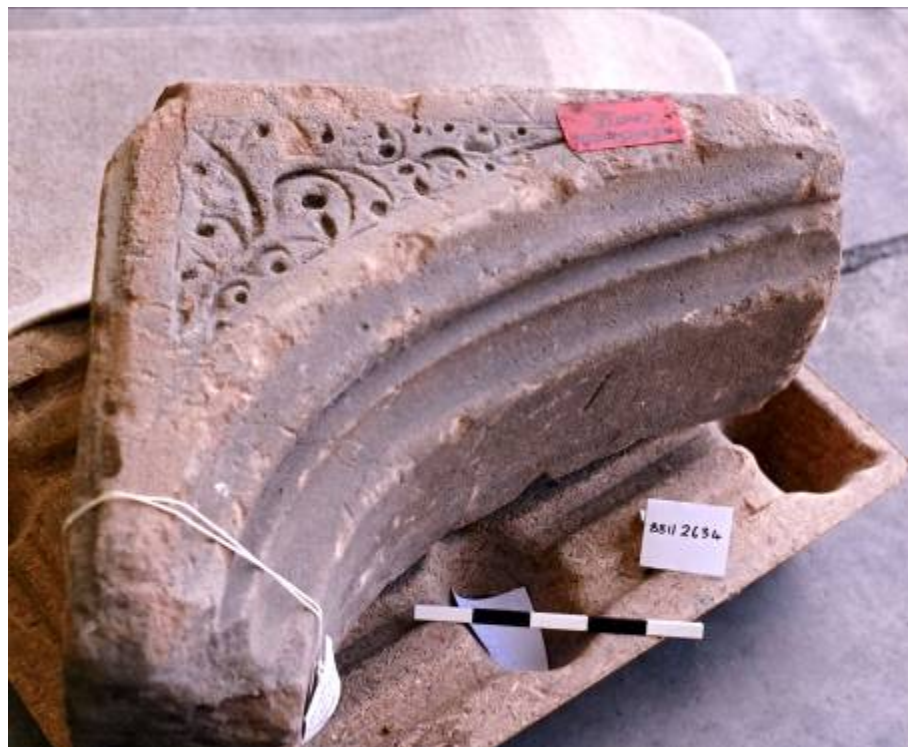
Fig B. Kenilworth Castle, spandrel from a door-head: English Heritage store, Atcham, No. 88112634 (scale, 25cm). Photograph: author

An attribution to Leicester of the east wall of the Gallery Tower’s courtyard is suggested by the fact that its foundations consist of reused medieval stones, almost certainly monastic spoil, and that it is secondary to the east wall of Northumberland’s tiltyard. Foundations for a D-shaped projection in the south-west corner of the courtyard may relate to the new windows of Leicester’s Tower (figs 1 and 4). When the area of the sluice-gate directly below the tower was cleared in 1965-66, a number of loose worked stones were found which might well have fallen there at the demolition of the tower in the seventeenth century.⁵ None of these stones is firmly identified today in the Atcham collection, but one possible candidate is half a door-head with typical sixteenth-century cyma and cavetto mouldings, and with distinctive carving in the spandrel, consisting of a stylised foliate pattern interspersed with drill-holes to give an effect not unlike strapwork (fig B).⁶ Nothing like it is found in Leicester’s main works

elsewhere in the castle, so it might belong with work pre-dating 1570-72. Its decorative quality would be rather suitable for the ‘ladies’ room’ in the Gallery Tower.

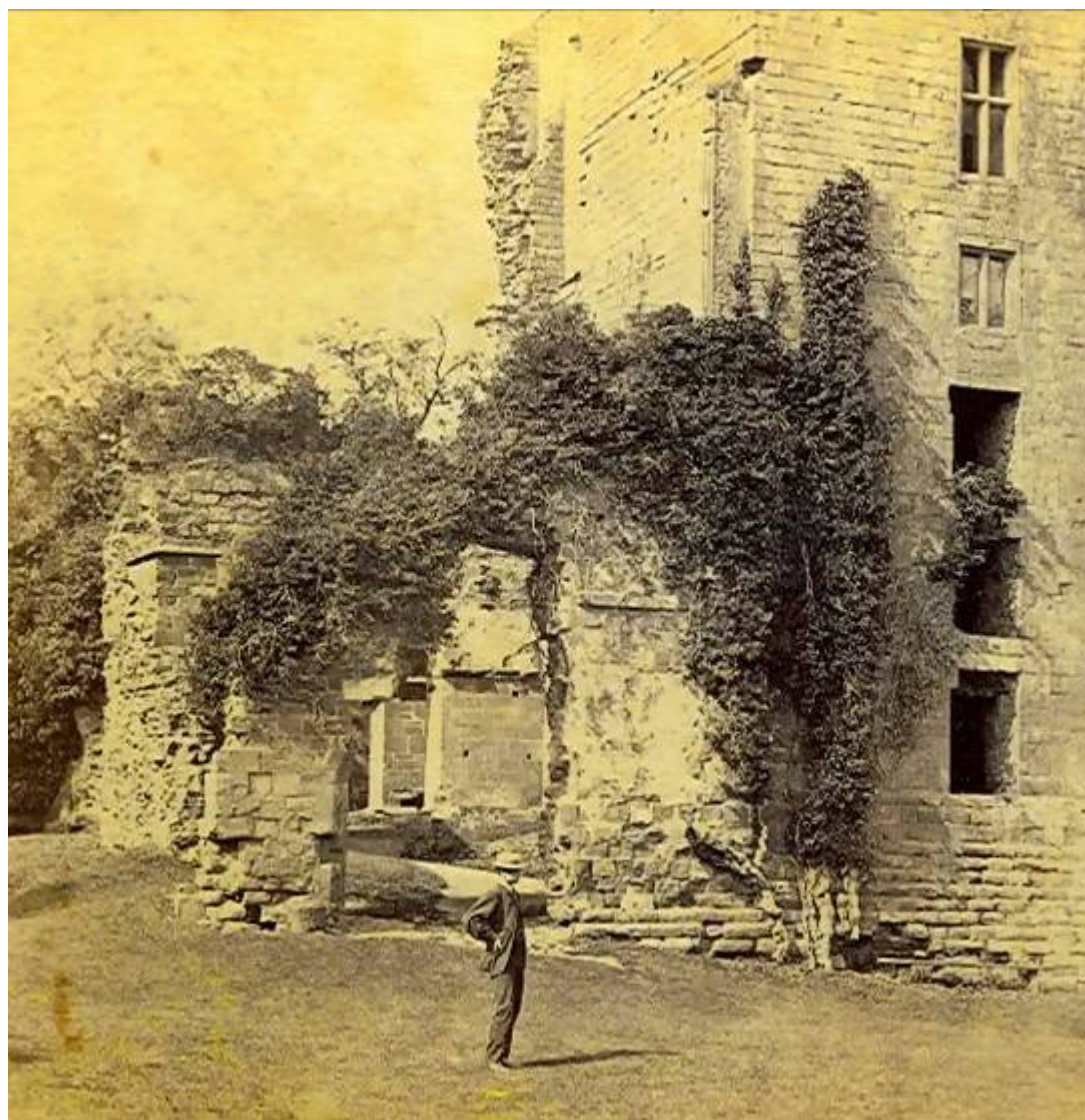
*Fig D1. Kenilworth Castle, the forebuilding, south elevation; the south exterior c. 1860.
Stereo pairs photograph © Graham Gould collection*

Useful additional evidence for dating the forebuilding as a link to the garden might have been provided by the style of the doorway in its northern wall, but unfortunately this aperture is entirely a later nineteenth-century reconstruction, as is the entrance from the inner court in the south wall. Both are in an austere neo-Norman style, which old photographs prove is entirely a Victorian invention in the case of the south doorway, and thus probably for the north one as well (cf. figs 10 and D1).⁷ Clark commented in 1884 that the Norman south doorway ‘has in part been replaced by an entrance of Perpendicular date, now also broken away’,⁸ his evidence presumably being the left jamb which appears in the photograph of c. 1860 (fig D1). Clark’s ability to distinguish Perpendicular features from Elizabethan is not sure-footed and, as this jamb no longer survives, it is impossible now to ascertain whether it was late medieval or actually forebuilding Phase 1 work of 1569. The present paving of the loggia, and the stone steps to the garden, are also unreliable, being twentieth-century (probably Ministry of Works) and later nineteenth-century respectively (fig D2).

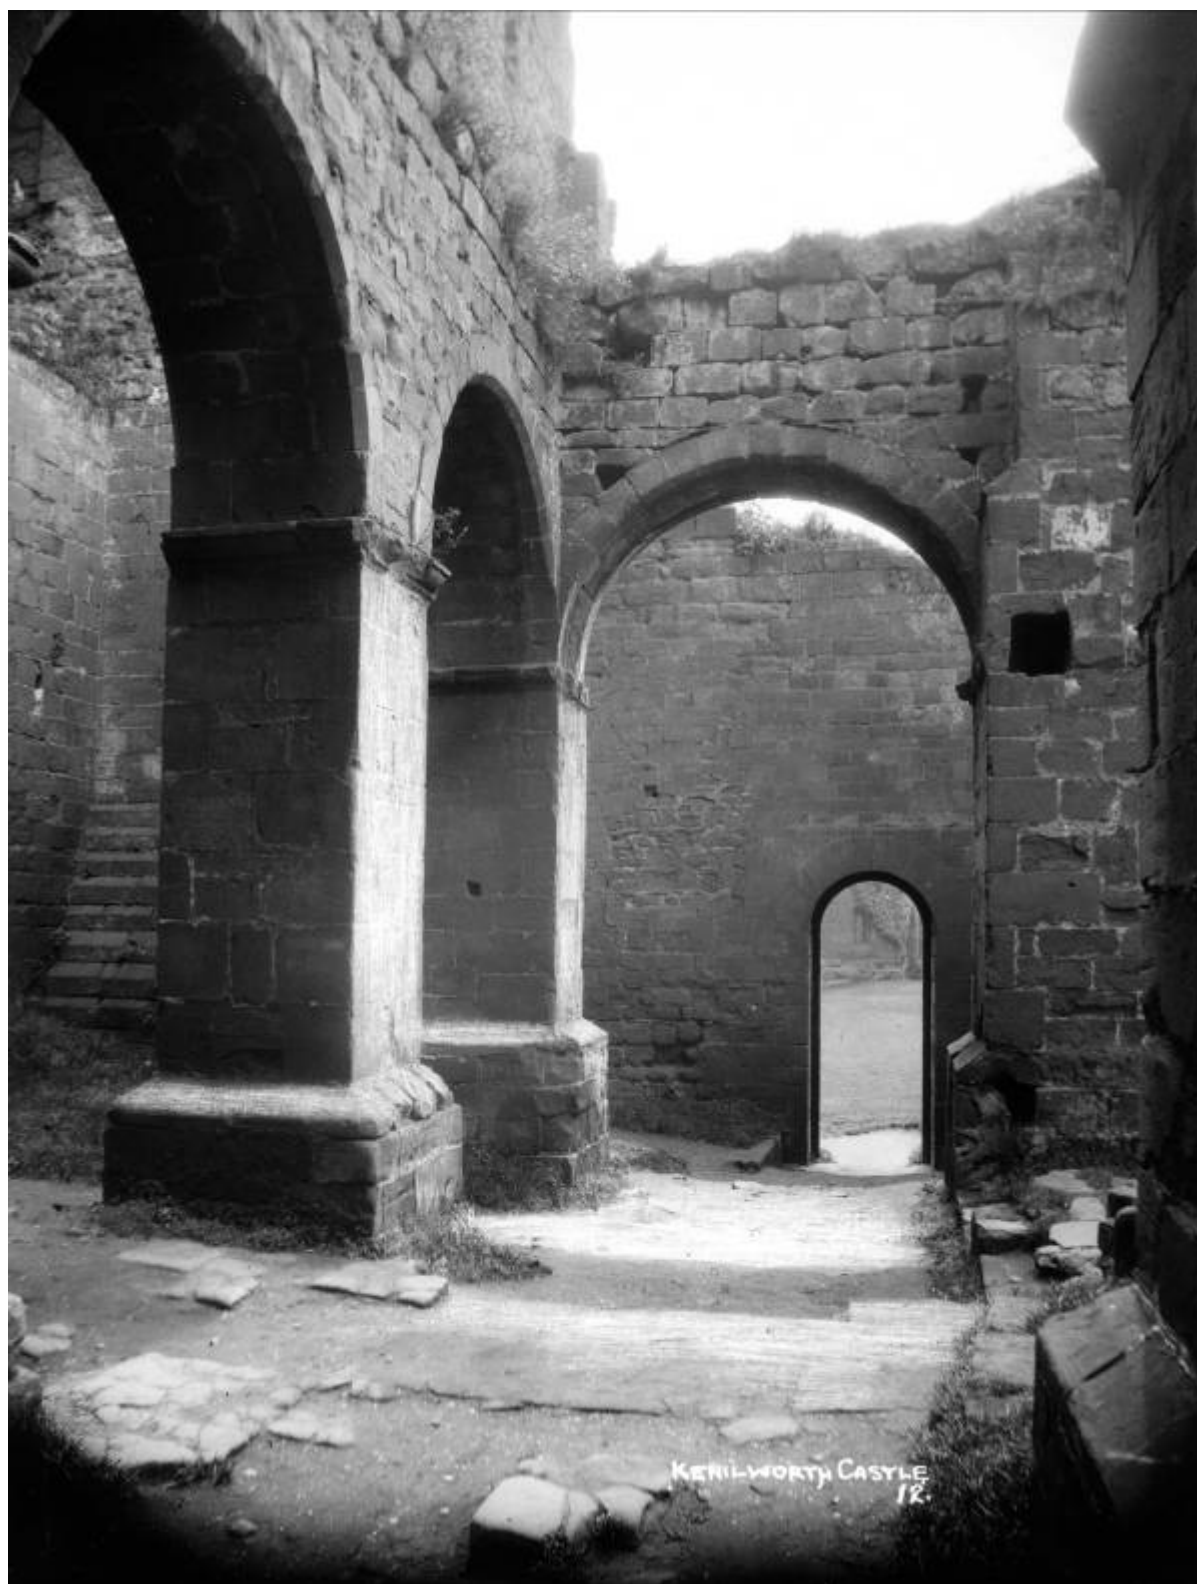
*Fig D2. Kenilworth Castle, the forebuilding: the loggia, looking south, probably c. 1900.
Photograph: © English Heritage*

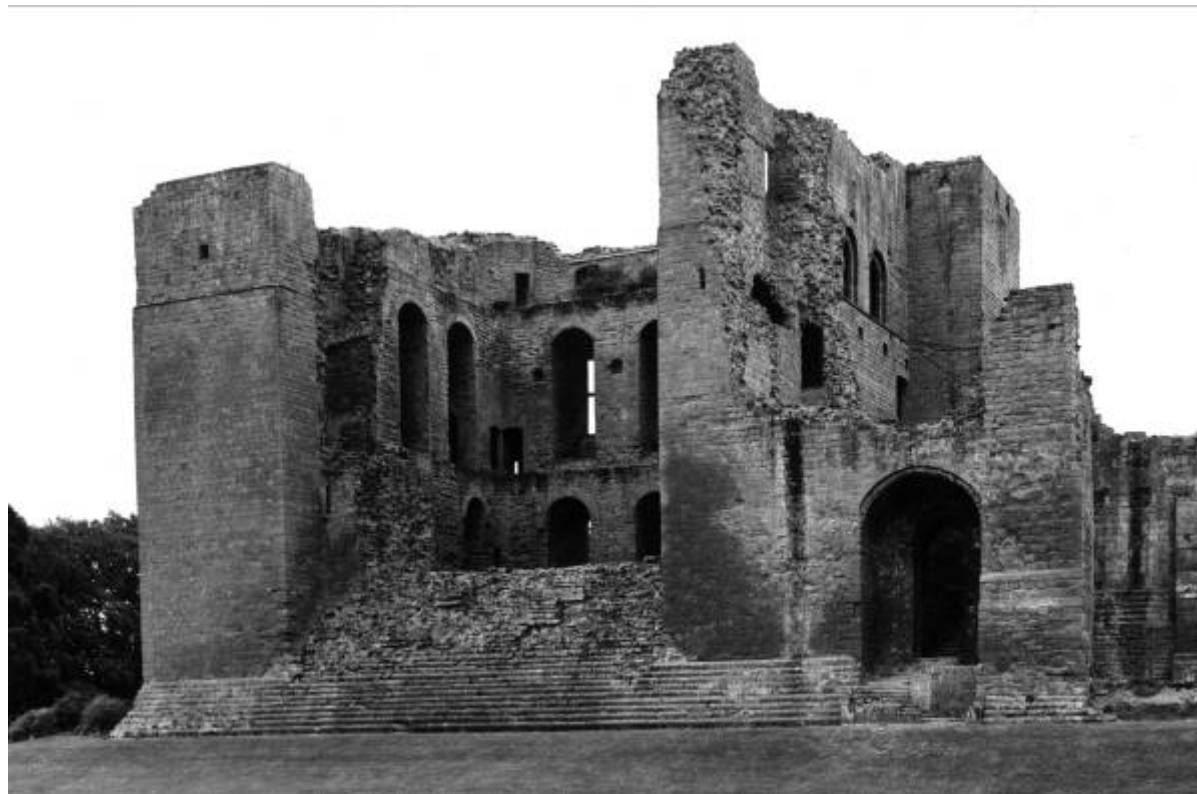
*Fig F. Kenilworth Castle, the great tower and forebuilding from the north (garden side).
Photograph: Alan Watson c. 1980 © History of Art, University of Warwick*

It would be very interesting to know how the lost north elevation of the great tower was treated in Leicester's time, and especially whether the treatment of the ground floor as a loggia was repeated on the garden side (fig F). The only two known views of it before the seventeenth-century slighting are two Hollar engravings in Dugdale, but close examination of them unfortunately suggests that they have no value as accurate records (fig 3, centre).¹⁶ Internally, on the stub of the former north wall adjoining the north-east turret, the jamb of a Romanesque rere-arch is still visible (though heavily restored), suggesting that the lower floor originally had splayed apertures similar to those in the south wall (fig 18, bottom left); but there is no clue as to whether they were altered by Leicester.

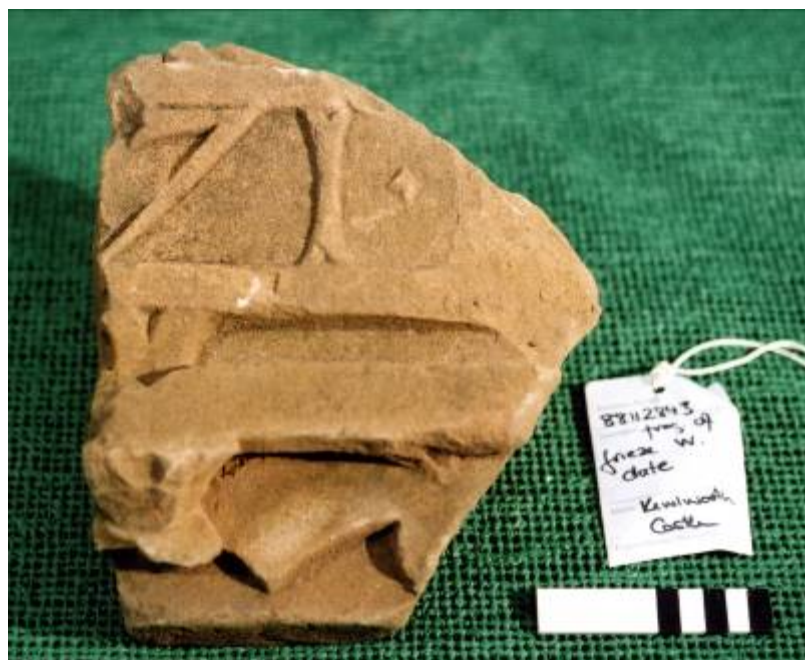
Fig G. Kenilworth Castle, stone fragment carved with [15?]71: English Heritage store, Atcham, No. 88112843 (scale, 10cm). Photograph: author

possibly be one and the same as part of an incomplete Elizabethan sandstone carving, still bearing the numerals '71', in the English Heritage store at Atcham.¹⁹ It appears that it was loose on a window sill in Leicester's Building for many years, and was probably amongst the stone collection noted there in 1923 (fig G).²⁰ There is no evidence that it was actually a date-stone on the building: it seems to belong with other fragments at Atcham which derive from fittings such as an overmantel.

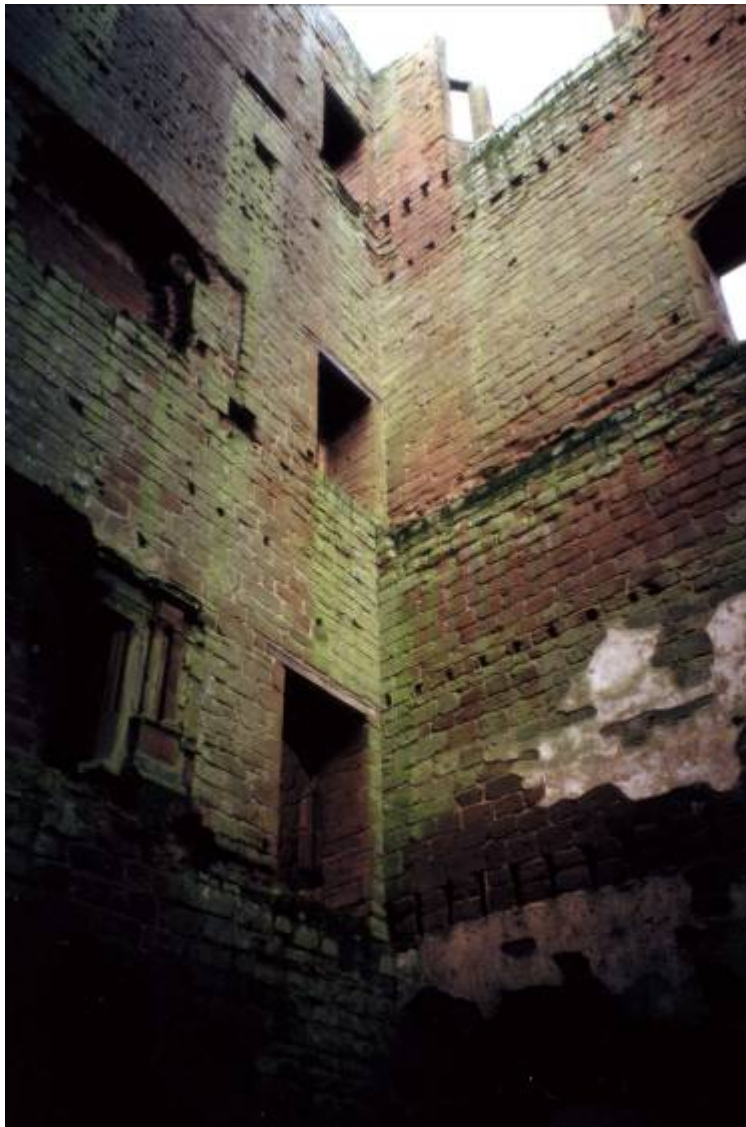
Fig H. Kenilworth Castle, Leicester's Building, interior: area B, west and north walls, from the basement. Photograph: author

A curiosity of Leicester's Building is the distribution of the stone door-frames (fig 16), which are only applied to one side of the aperture, the other side being plain wall with a timber lintel (e.g. fig 24). Doubtless this plainness was masked originally by a carved wooden frame or by an interior porch. The actual door would have been hinged from the stone frame, opening inwards. One searches in vain for an overall logic behind the arrangement, which is used almost consistently throughout the three upper floors; for example, in area B a plain frame appears in the same position in each chamber (fig 24, right). In the withdrawing chamber on the principal floor, three of the doors possess stone frames, whilst the fourth one at the north-west corner is plain (fig H, right). The latter may have been concealed originally by an interior porch as a waiting area, perhaps extended into a screened corridor across the north

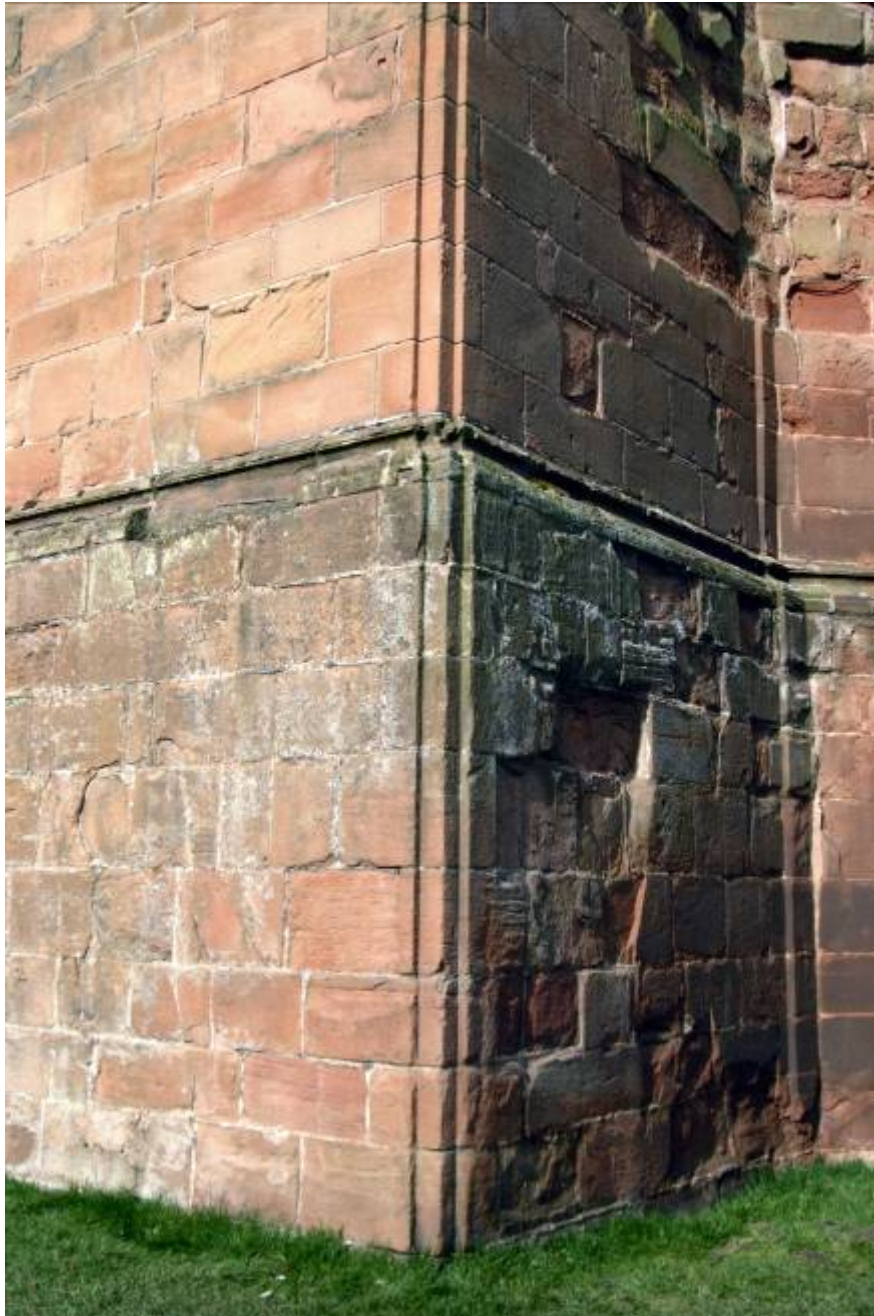
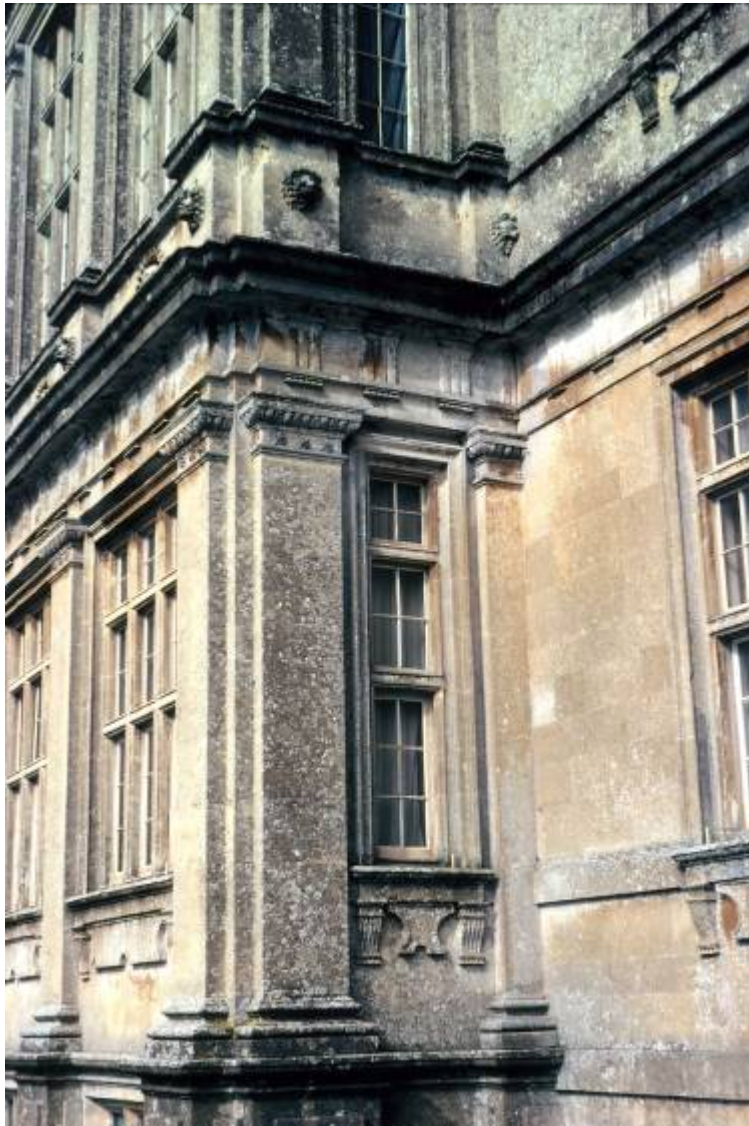
Fig M1. Kenilworth Castle, Leicester's Building, a corner detail. Photograph: author

A small but unusual masonry detail of Leicester’s Building may have its source in Spicer’s past at Longleat. The external corners of Leicester’s Building have a delicate double-step in plan, a curious conceit which has the effect of heightening the linear quality of the edges (fig M1). In this period, the most likely parallels are found in the bay windows at Longleat, in the way the pilasters are set back from the corners (fig M2). It has been suggested to the author that there is a resemblance to the corners of the twelfth-century great towers at Rochester Castle (Kent) and Castle Hedingham (Essex), but these are only single-stepped. It is also less clear how they would relate to Leicester’s Building, especially as the great tower at Kenilworth does not employ this feature. Presumably the masonry of the bay windows is no earlier than 1572, and so slightly later than Leicester’s Building, but it is possible that the idea originates in the pre-fire Longleat of Spicer’s time. Robert Smythson generally does not
