# VISUALISING HUGH MAY'S ELTHAM LODGE

## SUPPLEMENTARY MATERIAL

**APPENDIX SM5** LATER HISTORY AND CHANGES TO ELTHAM LODGE, 1750–2018

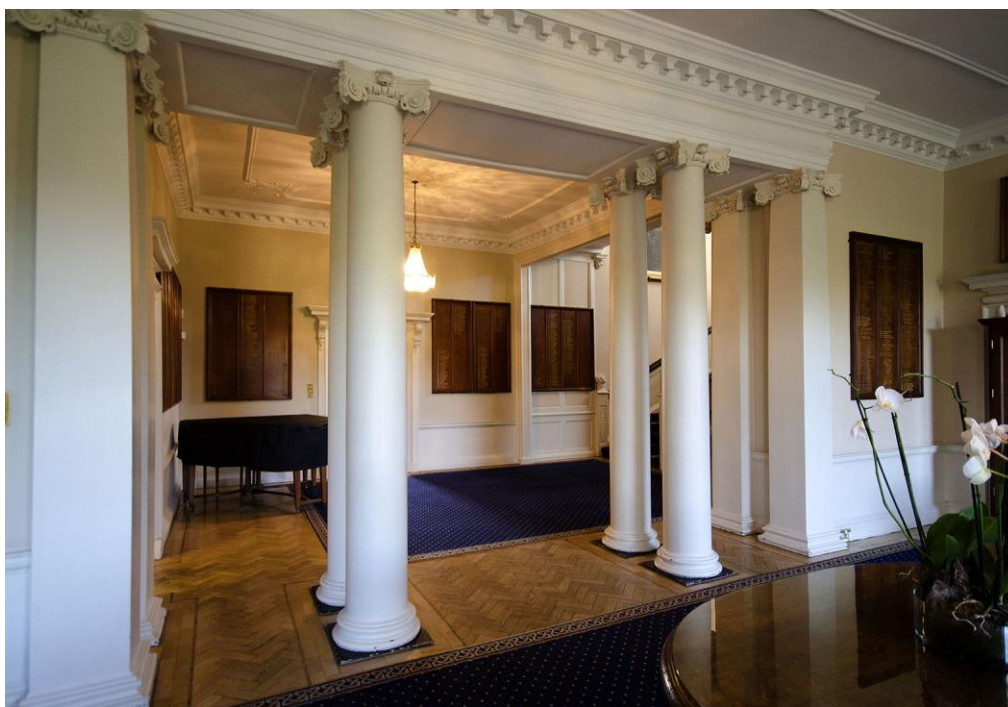
**Fig A2.** View of Hall, G1. *Photograph:* David Wrightson

Avray Tipping and others suggested that the Ionic screen between G1 and G4 was inserted in the nineteenth century.<sup>6</sup> However, the columns are shown on the 1805 plan, their marbled decoration is visible in early photographs, and the entablature over them fits seamlessly with the cornice around the remainder of the room. All therefore probably belong to the alterations of the 1750s, as Garnier has noted (fig A3).<sup>7</sup> Rooms G4 and G9 have 1750s cornices and doorcases matching that in G1 and 1750s plaster ceilings.

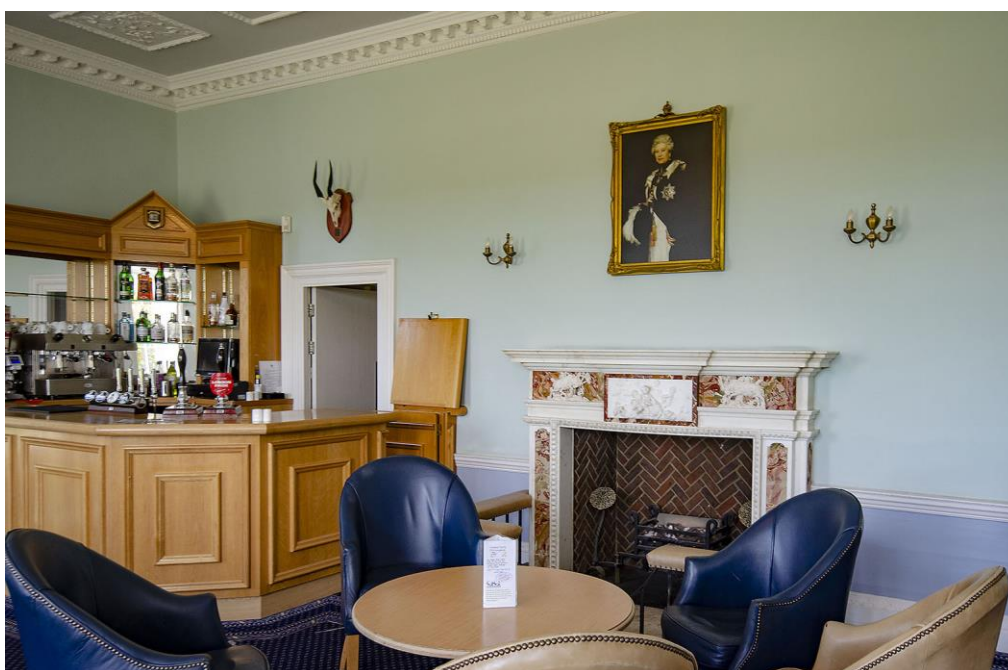
**Fig A3.** View of Dining Room, G10. *Photograph:* David Wrightson

The original plan was nonetheless largely retained, although a new and enlarged Dining Room (G10) was created on the ground floor, with a marble chimneypiece ascribed to Henry Cheere (fig A2). The unusual square-panel design of the ceiling clearly reflects the design of the original ceiling in G11, while the central oval appears to reflect the ovals found in other original ceilings. This must surely be a conscious *homage* to the earlier plasterwork in the house. The back hall (G9) was narrowed on the east to be symmetrical about the garden door. In G12, the 1805 plan shows a doorway in the north wall, which relates to G8 becoming a service space, the back hall. The splayed east window, which has no surround or shutters, appears to have been made blind in the 1750s and opened up subsequently.

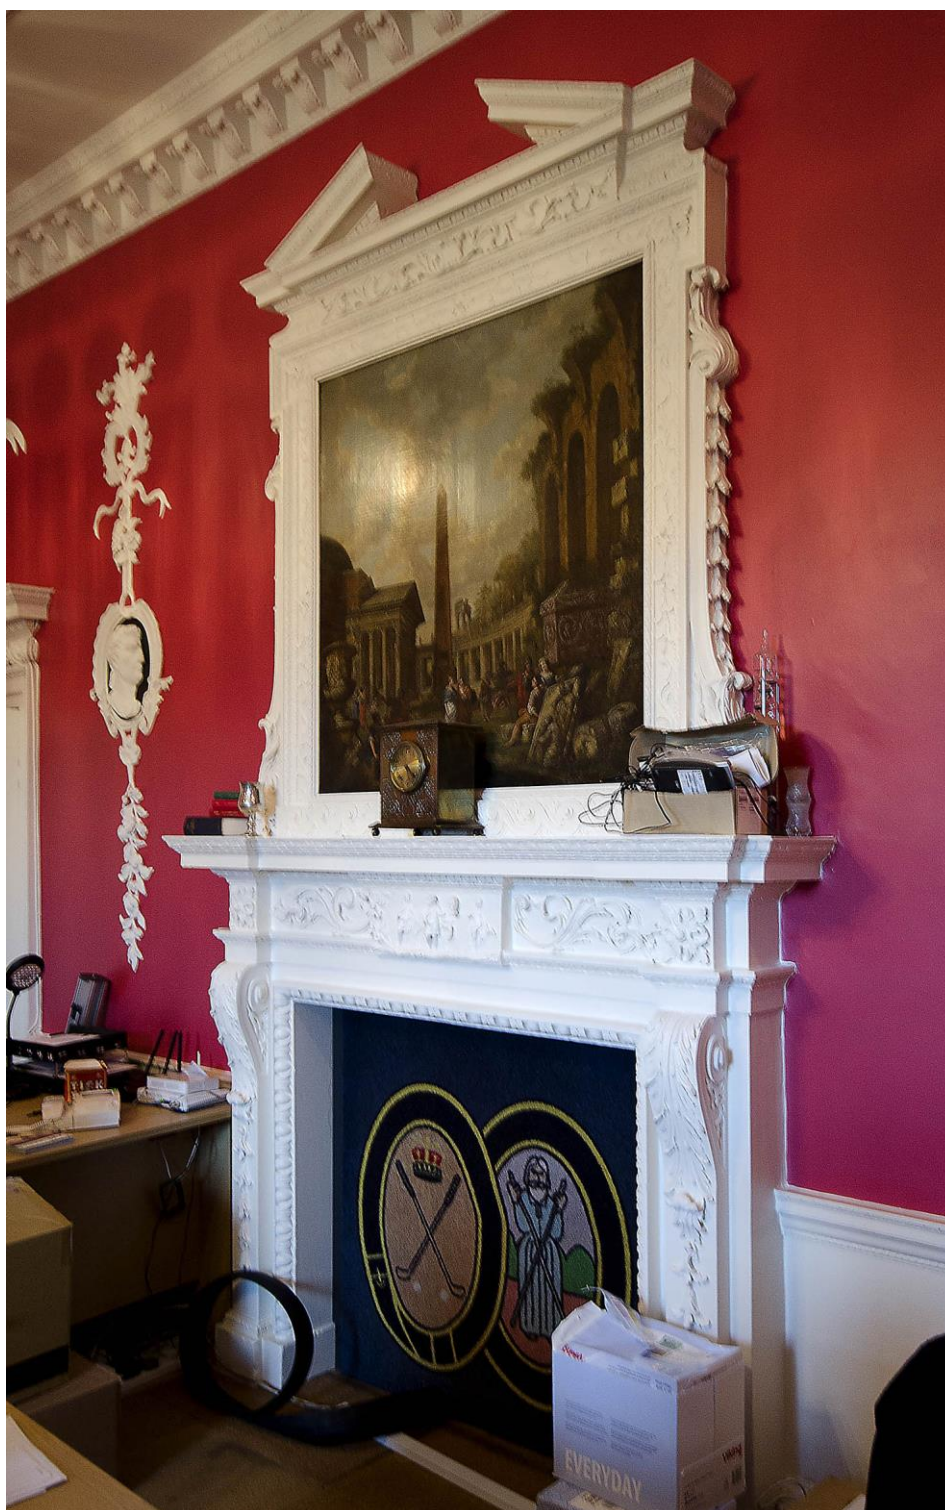
**Fig A4.** View of north-east corner room, ground floor G2. *Photograph:* David Wrightson

The three rooms on the north side of the house may possibly have been re-planned. The north-east room (G2), marked as the dining room on the 1805 plan, was given the most elaborate refitting with high-quality Rococo plasterwork which contrasts with the much more severe classical chimneypiece and overmantel (fig A4). The original window in the east wall must have been made blind in the 1750s when the room was replastered; it was reopened as a

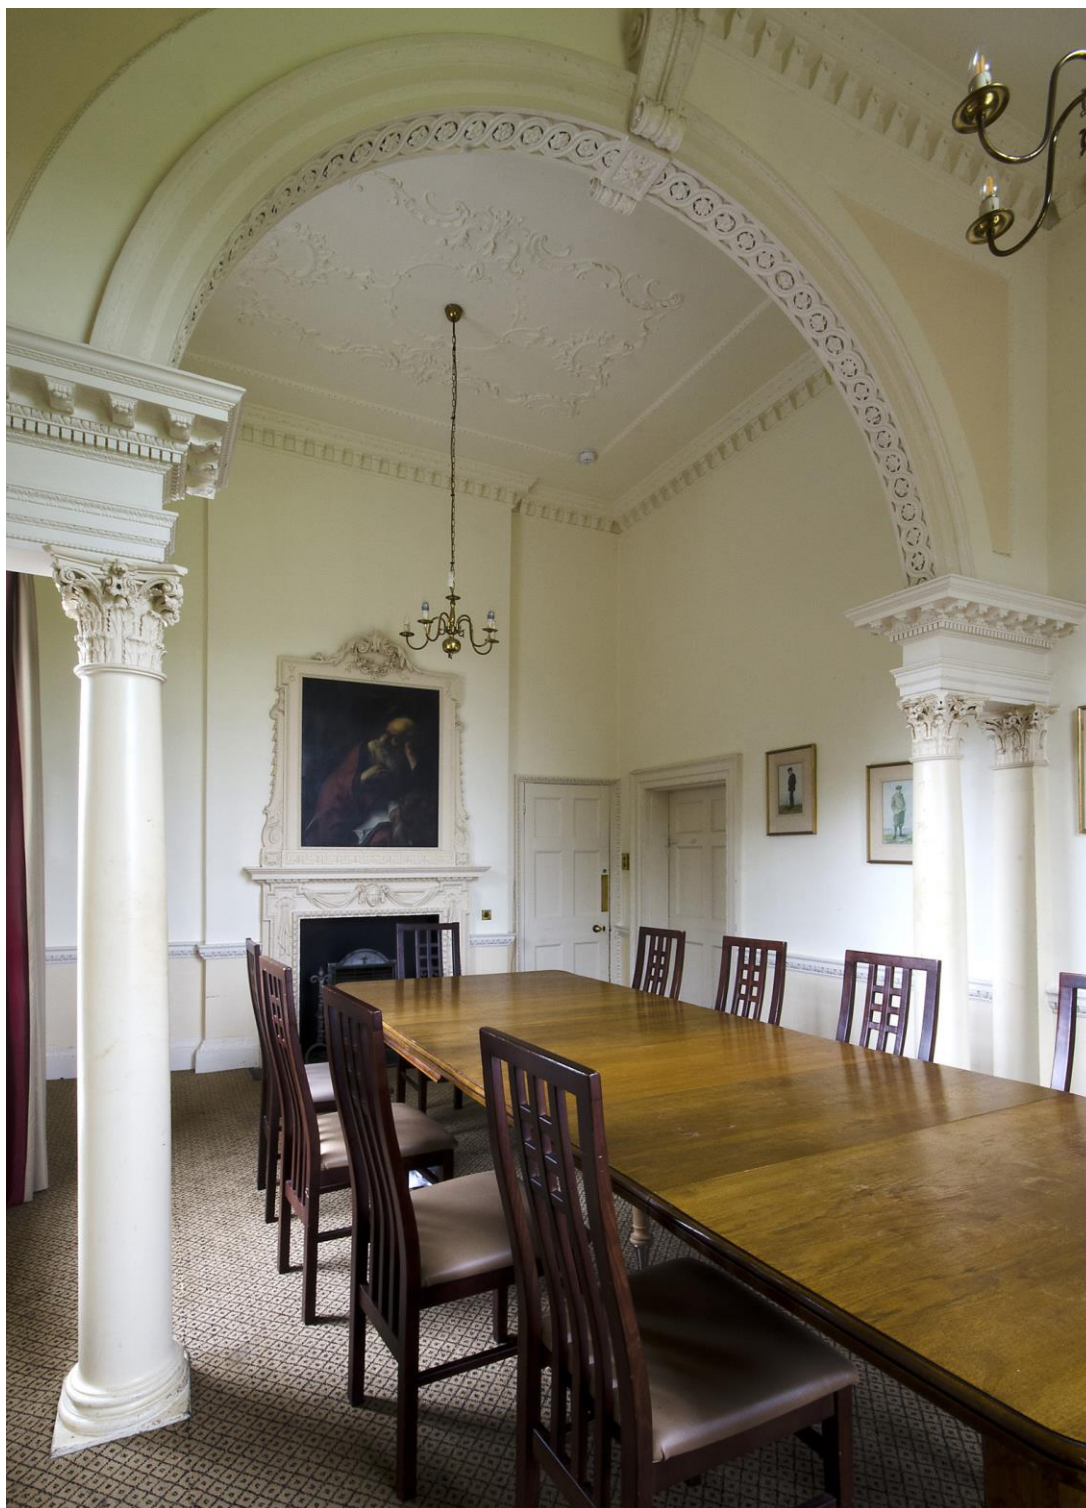
**Fig A5.** View of north-east corner room, first floor, F6. *Photograph:* David Wrightson

The north-east corner room (F6) was enlarged a little in the 1750s by moving the wall slightly to the west to create an elaborately-decorated bedroom which formed a suite with F7, and (later) had access to the secondary stair. In addition to good plasterwork and carving, it has a chimneypiece copied from a William Kent design, with an overmantel containing a painting of St Mark (at one time attributed to Sebastiano Ricci). The end (north) window was made blind and a columnar screen based on the Serliana inserted to form a bed alcove (fig A5).<sup>11</sup> At the south-east corner, the closet F4 was similarly arranged as a bedchamber. The 1805 and 1921 plans record the columns and answering pilasters of its Serliana screen, of which the pilasters alone survive and remain visible (fig 34b; the arch is now concealed and a false ceiling hides a shallow oval plaster dome in the principal space (fig A6).<sup>12</sup>

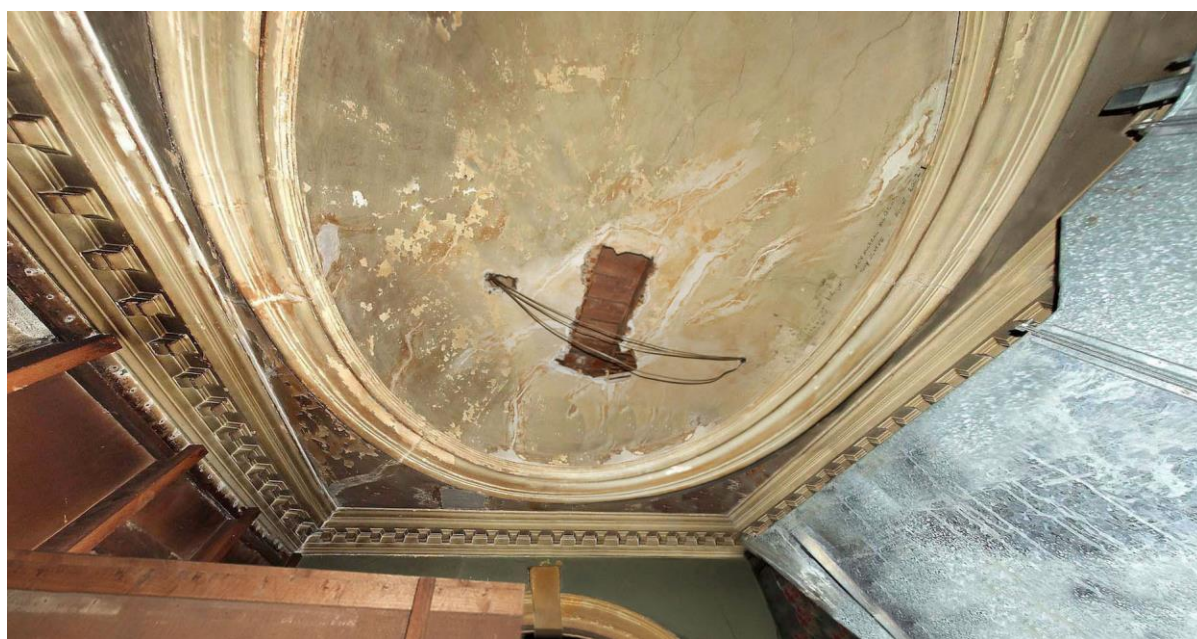
**Fig A6.** Domed ceiling of south-east corner room, first floor, F4, looking south. Graffiti on the springing of the west side of the dome record the names of men working at Eltham: Peter Edward Boggis on 1 May 1984, and Aide Micheal McGrath and Toby Clark in August 2002. *Photograph:* David Wrightson

<sup>12</sup> The existence of the arch in F4 is confirmed in the 1838 dilapidation schedule which specifies for the ‘Dressing Room adjoining S.E. Angle’, ‘...Refix Cap of pilaster’. DHC, D-PIT/E/111/1.

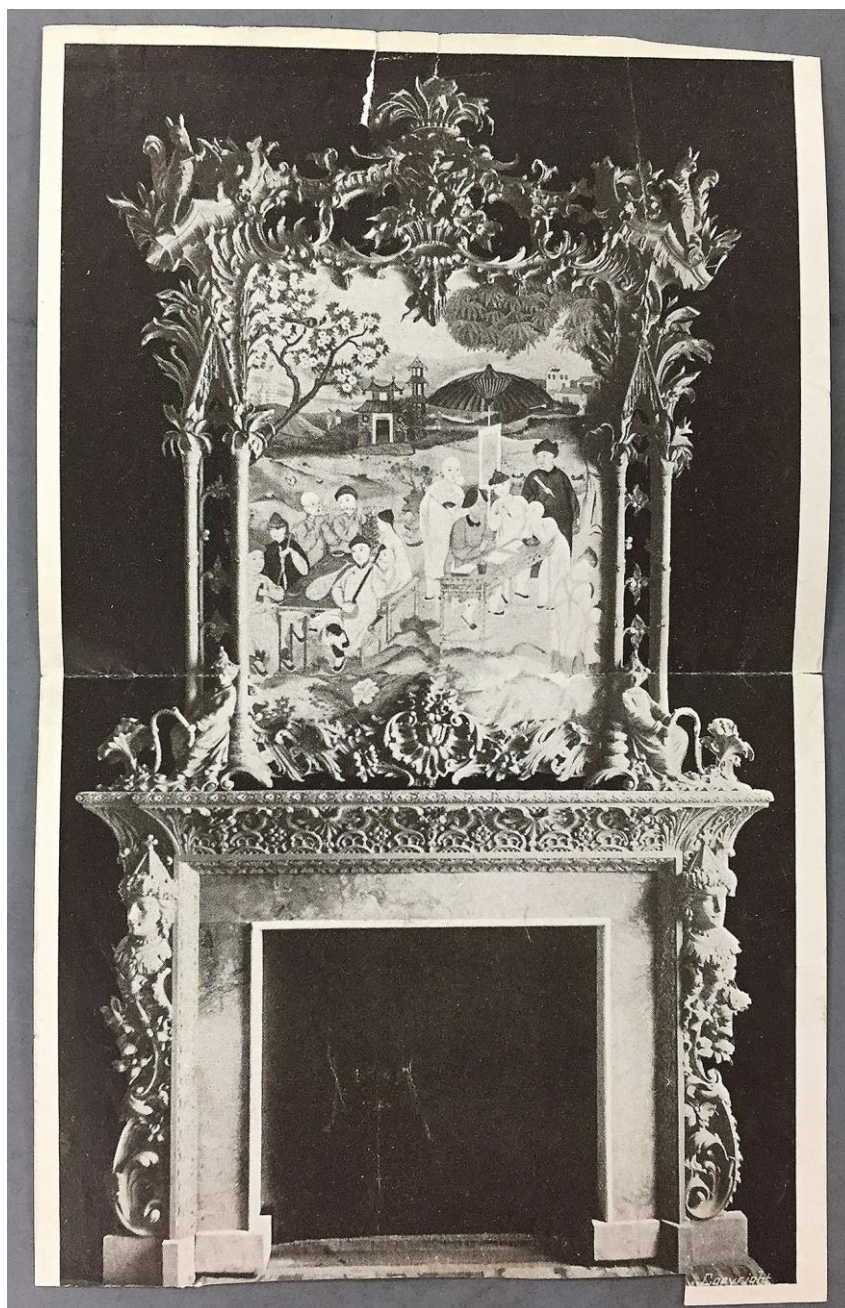
**Fig A7.** Chinese chimneypiece from F7, photographed in 1910 (TNA CRES 35/2775).

The principal room in the north-eastern quarter of the first floor, adjacent to F6, was called the 'India Sitting Room' in 1805 (F7), and as its name implies was decorated in an oriental

style in the 1750s with a *Chinoiserie* chimneypiece and Chinese wallpaper. To complement these features the room has a carved dado rail, deep coving with an elaborate frieze and doorcases with rich carving below the cornices. The location of the chimneypiece and wallpaper has been in doubt until recently, but it is securely located by the 1838 schedule of repairs, where the room called 'Bed Room No. 3' was between the north-east room and the 'Anti Room'. The repairs required within it included 'repair Chinese paper' and 'repair ornamental woodwork and chimneypiece'.

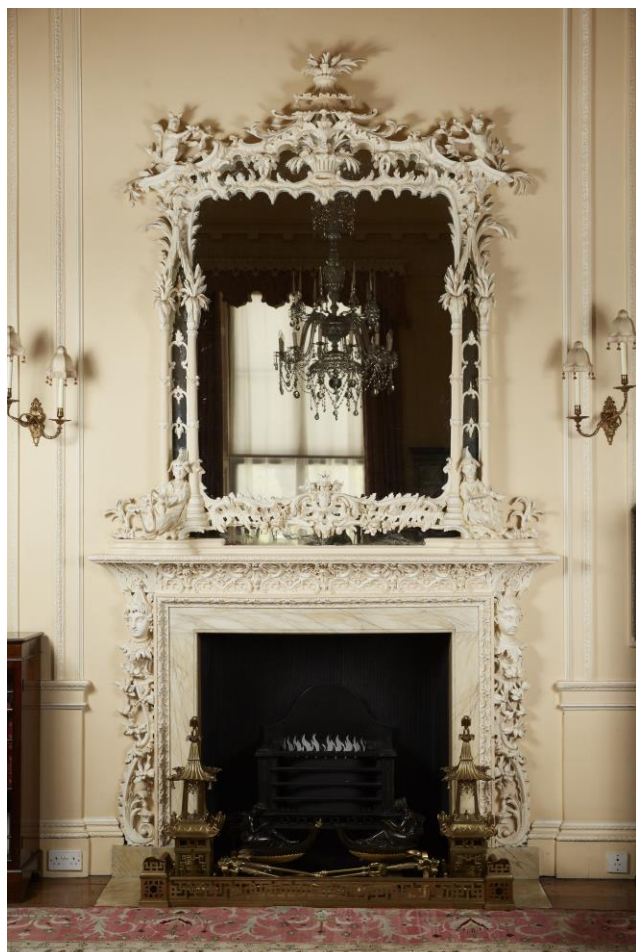
**Fig A8.** Chinese chimneypiece from Eltham Lodge, now in the Presence Chamber at Buckingham Palace. Royal Collection Trust, © Her Majesty Queen Elizabeth II, 2018

The Chinese chimneypiece was removed from this room at the request of Edward VII and was re-erected in 1911 for Queen Mary by Sir Charles Allom, in what is now the Queen's Presence Chamber in Buckingham Palace.<sup>13</sup> Documents in the National Archives speak of a request from Sir Sidney Greville, Groom in Waiting to the King (on behalf of Edward VII) for the 'Chinese Chippendale' chimneypiece.<sup>14</sup> A letter of 17 January 1910 says 'The King has heard...' about this, and says that golfers hang their caps and pipes on it. A

The chimneypiece and its overmantel survive, but the Chinese painting has since been replaced with a modern mirror (fig A8). A replacement chimneypiece was provided for the golf club by Lenygon & Co., the firm who removed the original. Avray Tipping seems to have been unaware of all this, and wrote lamenting the lack of appreciation of the beautiful rooms at Eltham Lodge:

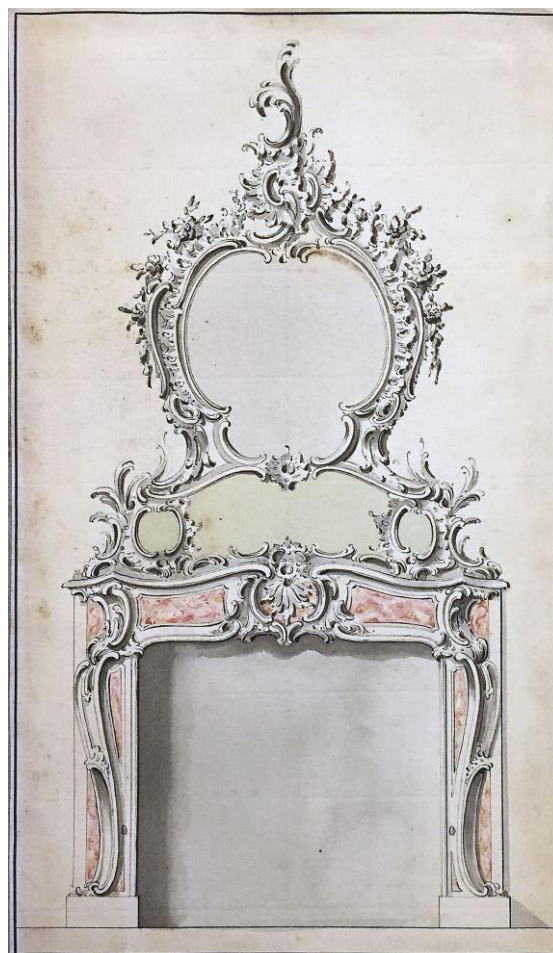
**Fig A9.** Design for a chimneypiece by Robert Taylor, c 1750–55 (A&TI ARCH.TAY.2, fol 6).  
*Photograph: Sally Jeffery*

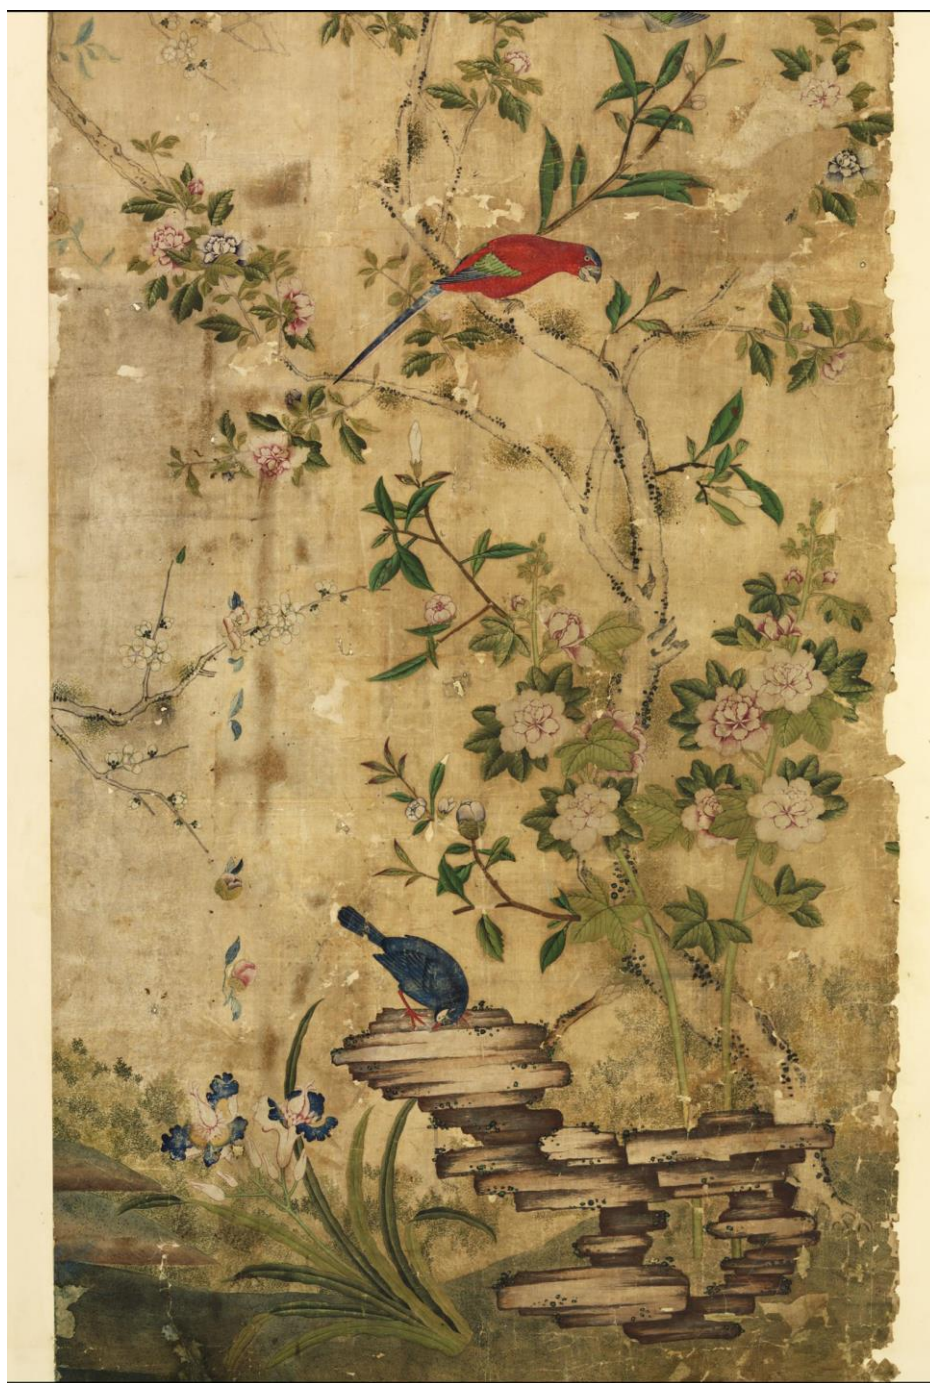
**Fig A10.** Chinese wallpaper panel from Eltham Lodge (Victoria & Albert Museum, London, E2087A-1914).

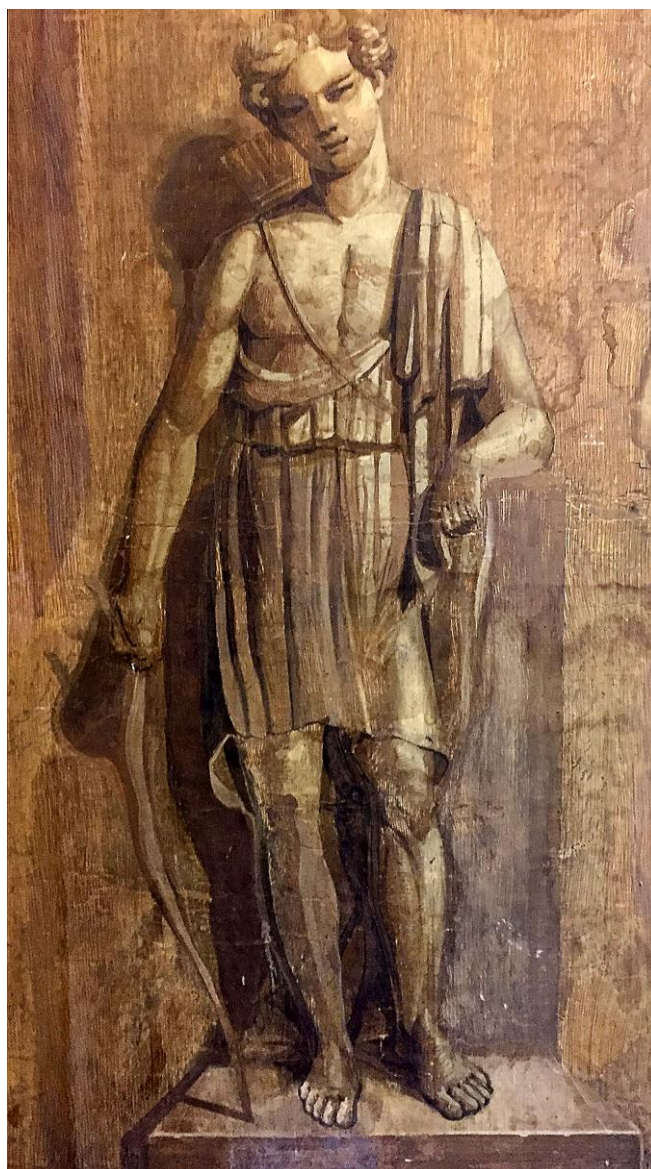
**Fig A11.** Wallpaper panel from the great stair at Eltham Lodge. © Museum of London.  
*Photograph: Sally Jeffery*

The wallpaper remained in place until the twentieth century, when parts of the scheme can be seen in photographs of the main staircase (see fig 31). The paper in the entrance hall and staircase was conserved in 1919-20 but thereafter the saga of the attempts by the Office of Works to retain the damaged *trompe l'oeil* 'old paper' against the wishes of the Golf Club rumbled on for many years. Sections were removed during the restoration work in 1956 and sent to the London Museum (now the Museum of London) where two figure panels from the staircase are conserved (fig A11).<sup>39</sup> The paper in the south hall (G9) was restored at this time but after further damage it was finally removed in 1963. A Mr Molesworth of the V&A was approached about it and at first considered taking it to use at Osterley or Ham, but afterwards Mr J. T. Hayes, Assistant Keeper at the London Museum, offered to take it for the new museum in the City of London to be formed from the London Museum and the Guildhall Museum (the future Museum of London). It was intended to use the paper in its entirety on the walls of a room with objects of the same period. This was a more definite offer and was accepted. Transport was arranged to the British Museum for storage and the paper had been removed by 27 February 1963. It was reported to be either at Kensington or in store in Walworth on 30 October 1968. This wallpaper is not at the Museum of London and has not been traced.<sup>40</sup>
